# Manhole Inspection Summary

Manhole # S25K\_\_028MH

Insp Date: **3/26/08 2:52 PM**

**Location** Address: **215 S. Woodyear**

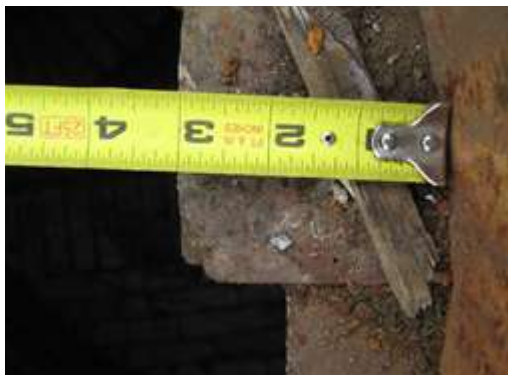
Defect 4

**Frame** Offset: **3** (in.) Condition: ☒ Sound ☐ Cracked ☐ Leaks

3inch offset

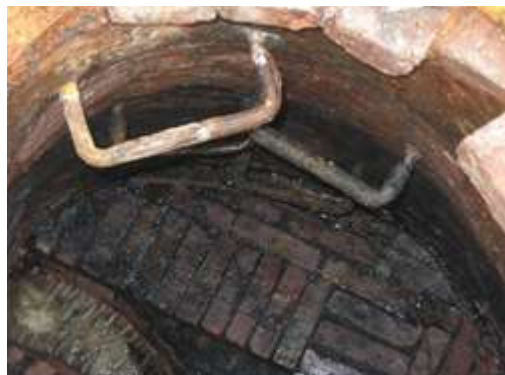
Defect 3

**Steps** Count: **4** Missing: **0** ☒ **Corroded**

corroded steps

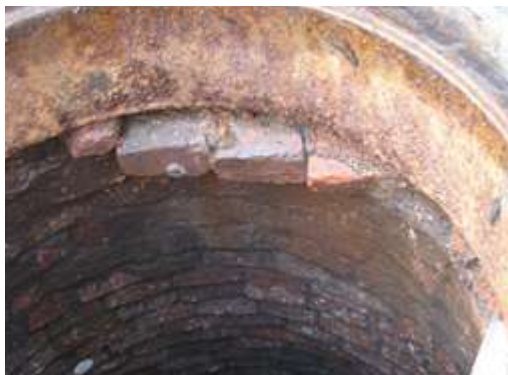
Defect 2

Condition: ☐ Sound ☒ **Cracked** ☐ Root Intrusion ☒ **Loose Brick** ☒ **Deteriorated**

Infiltration: ☐ None ☐ Joint ☐ Cracks ☒ **Mortar** ☐ Roots ☐ Wall

loose bricks infiltration frame-chimne joint

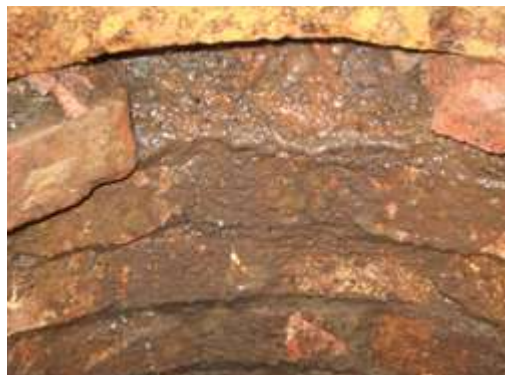
Defect 1

missing bricks and mortar, infiltration frame-chimney

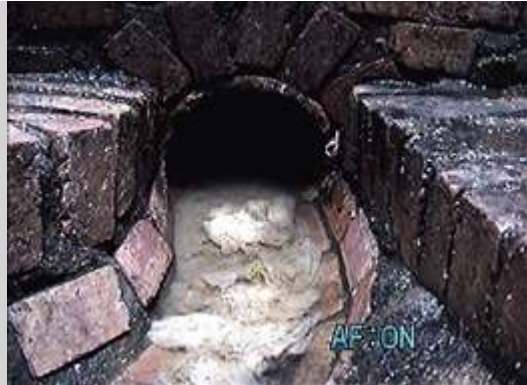
12 O'Clock Outflow

debris in  
channel
